Flutter Clearance of the Schweizer 1-36 Deep-Stall Sailplane

Michael W. Kehoe and Joseph F. Ellison

August 1985

Dryden Flight Research Facility
Edwards, California 93523

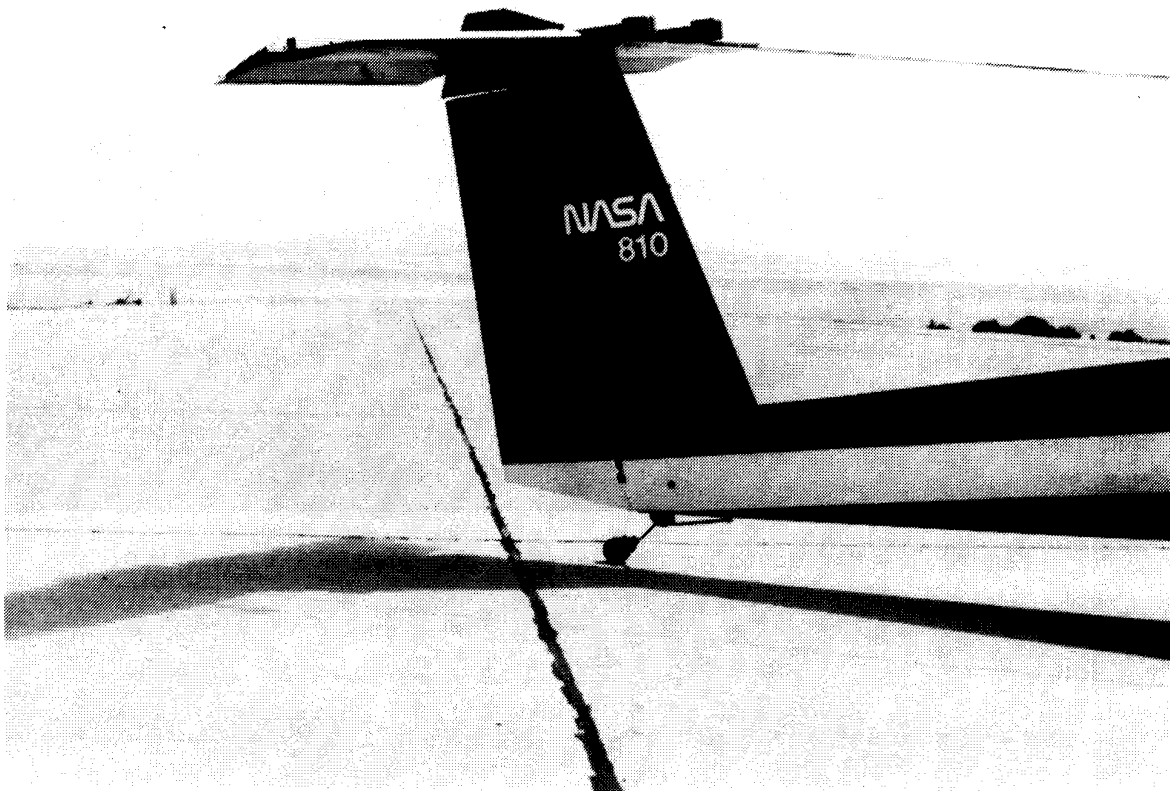
Figure 2.- Horizontal stabilizer in the normal flight position.

The Schweizer 1-36 sailplane (fig. 1) is a single-place, all-aluminum sailplane, except for the rudder, which is covered with fabric. The wing has a span of approximately 14 m (46 ft) and the fuselage length is approximately 6.4 m (21 ft). The horizontal stabilizer is a T-tail configuration with a span of 2.4 m (7.9 ft). The elevator is connected to the stick through a cable and pulley arrangement. The horizontal stabilizer in its normal flight position is shown in figure 2.

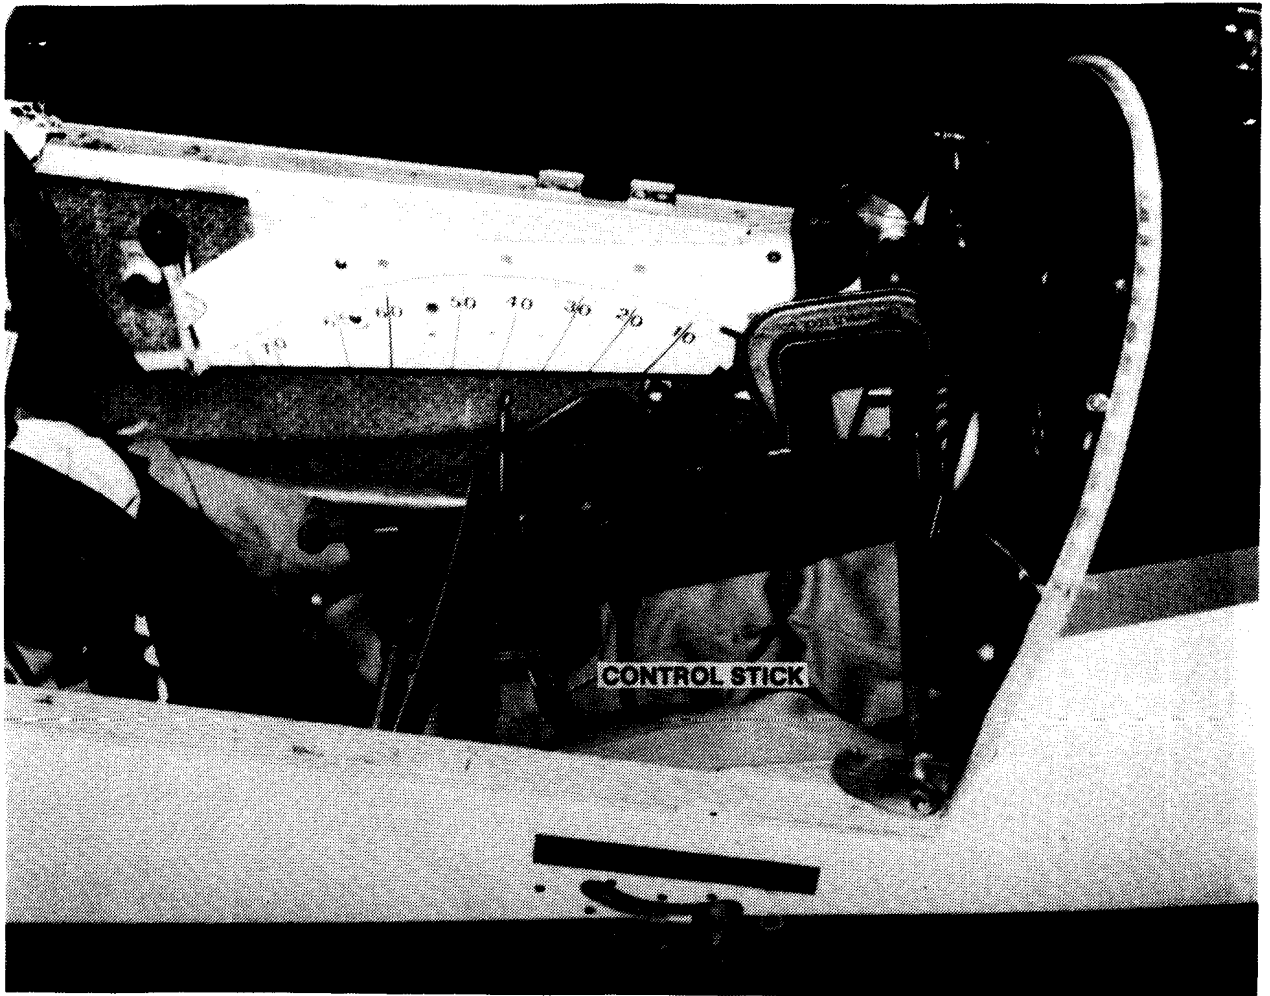
Figure 9.- Control stick locking mechanism.

The control stick was fixed in the cockpit by an arrangement of sheet metal and C-clamps as shown in figure 9. The rudder was fixed by clamping the rudder cables with C-clamps in the cockpit (fig. 10).

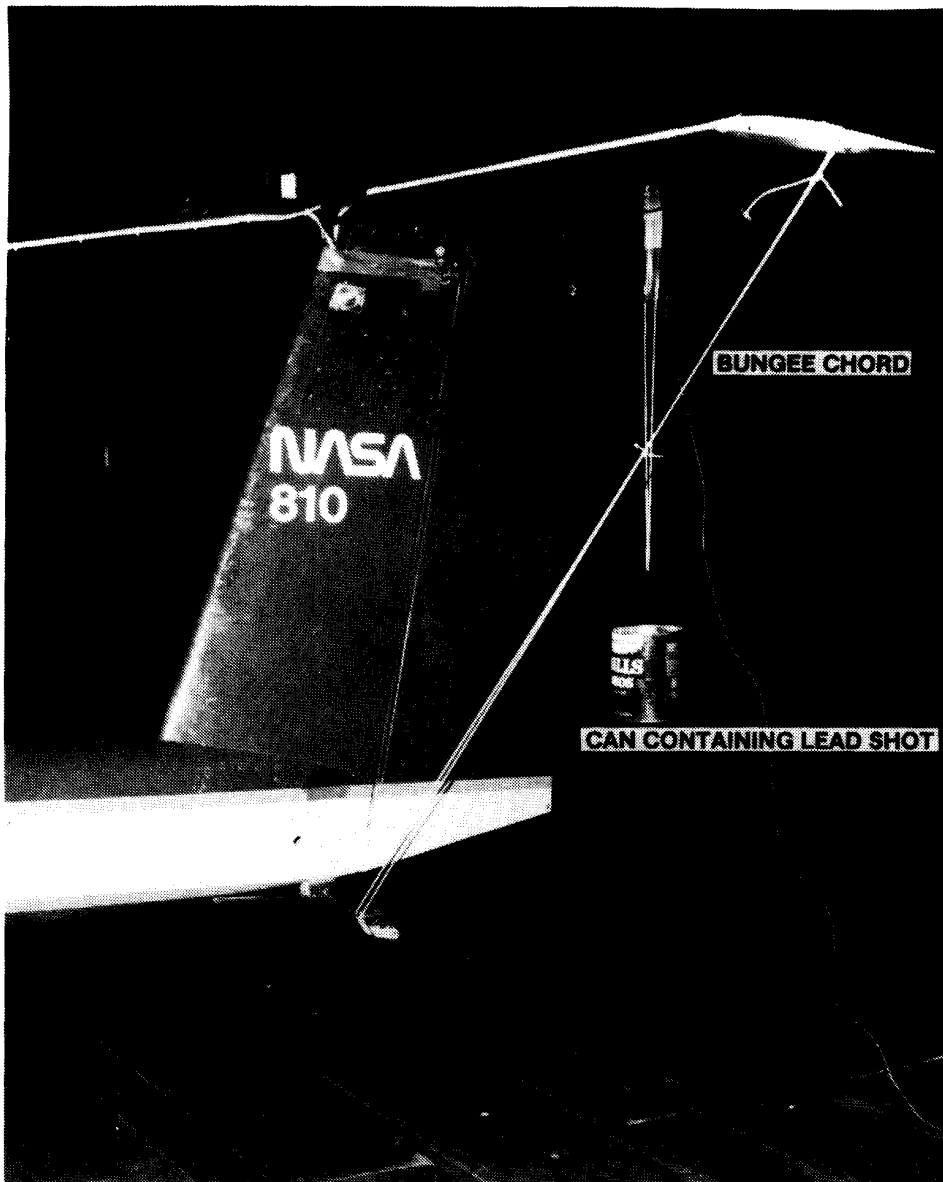
Figure 12.- Horizontal stabilizer preload.

There was noticeable freeplay in the horizontal stabilizer and in the elevators. The components were preloaded to enhance the frequency response. The horizontal stabilizer was preloaded with 0.95-cm (0.375-in.) diameter bungee chord (two strands) attached at the tip of the stabilizer and the tail wheel (fig. 12). The elevators were preloaded with 0.95-cm (0.375-in.) diameter bungee chord attached to cans each containing 4.54 kg (10-lb) of lead shot (fig. 13). The resonant frequency of each can/bungee system was approximately 1 Hz.

The horizontal stabilizer was preloaded to remove free play by attaching a bungee chord between one tip of the stabilizer and the tail wheel (fig. 12). Preloading in this manner appears to have lowered the stabilizer symmetric bending mode from 27.5 Hz to 23.41 Hz for the normal flight position.
